—Racepak Technical Bulletin—

Clutch Input Shaft Magnet and Sensor Installation

Racepak / Competition Systems, Inc.

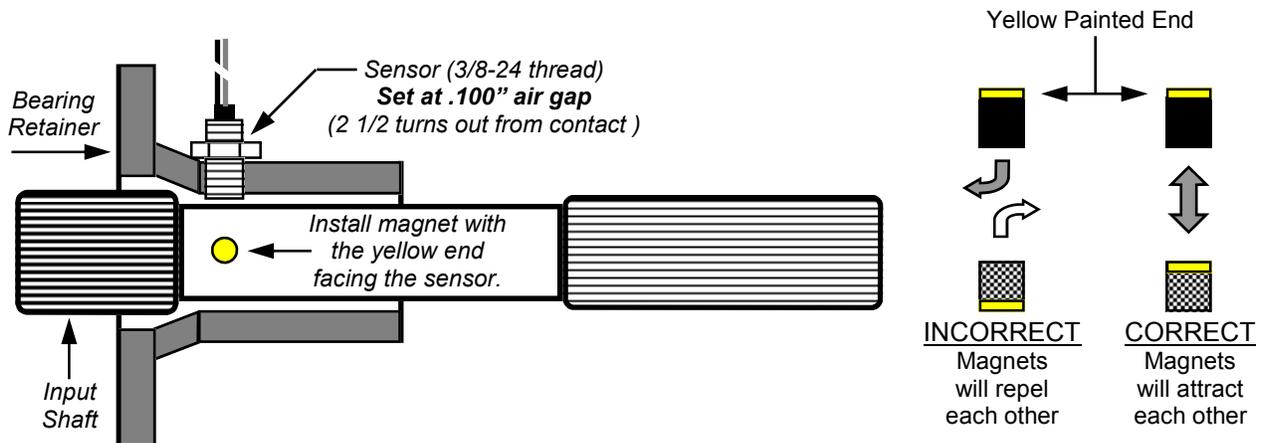
If you have an input shaft with the magnet already installed there is a simple test to insure that the proper end of the magnet (the North end) is facing the sensor, even if the yellow ink has been worn off. This test can be performed using the new magnet that was included with the data recorder kit. Hold the new magnet directly aligned over the top of the magnet in the shaft. With the yellow end of the new magnet facing upward (away from the shaft magnet), the two magnets should attract each other. This will indicate that the magnet in the shaft is installed properly. If the two magnets repel each other the magnet in the shaft is mounted incorrectly and must be changed.

The illustration below should further explain this procedure.

If the magnet in the shaft is installed with the wrong polarity facing the sensor it will be necessary to remove it and install the new magnet correctly.
